**UPDATE FILE FOR GYSMI 190****CONTENTS**

VERSION	MODIFICATIONS	DATE	AUTHOR
1.0	CREATION	27/10/2006	
2.0	PARAGRAPH 5) ANTISTICKING ADDED	25/05/2007	BRUNO BABLEE

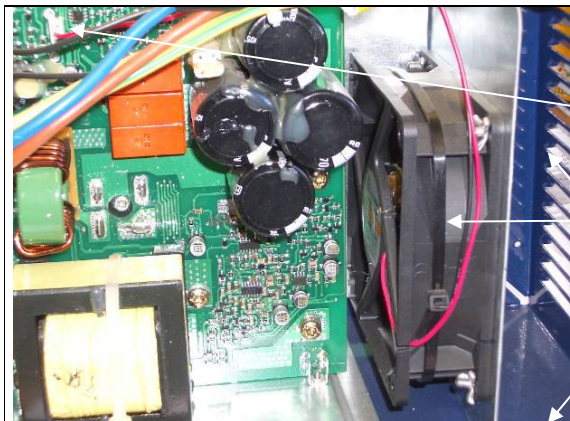
a) BURNT FAN CIRCUIT

You must modify the fan for machines manufactured before **September 2005**.

Check if there is some glue on the fan circuit : if there is no glue follows this procedure.

Disassembly of the fan :

- remove the fan connector
- cut the plastic collar which holds the fan to the aluminium plate
- remove the 4 rivets from the aluminium plate
- change the fan ref : 51021

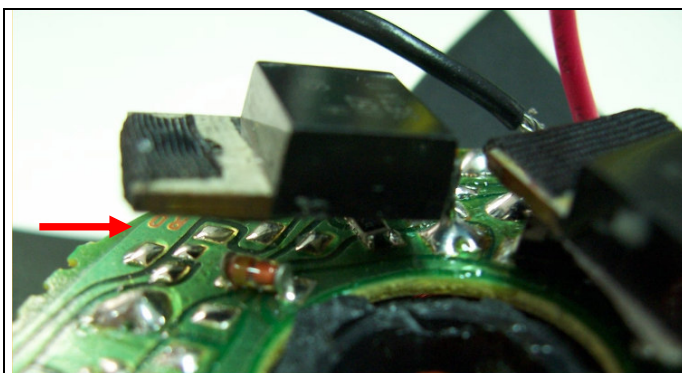
Modification of the fans 51021

There is a risk of short circuit between the transistor metallic part and the components below.

To eliminate this risk, insert some glue between the transistor and the PCB.

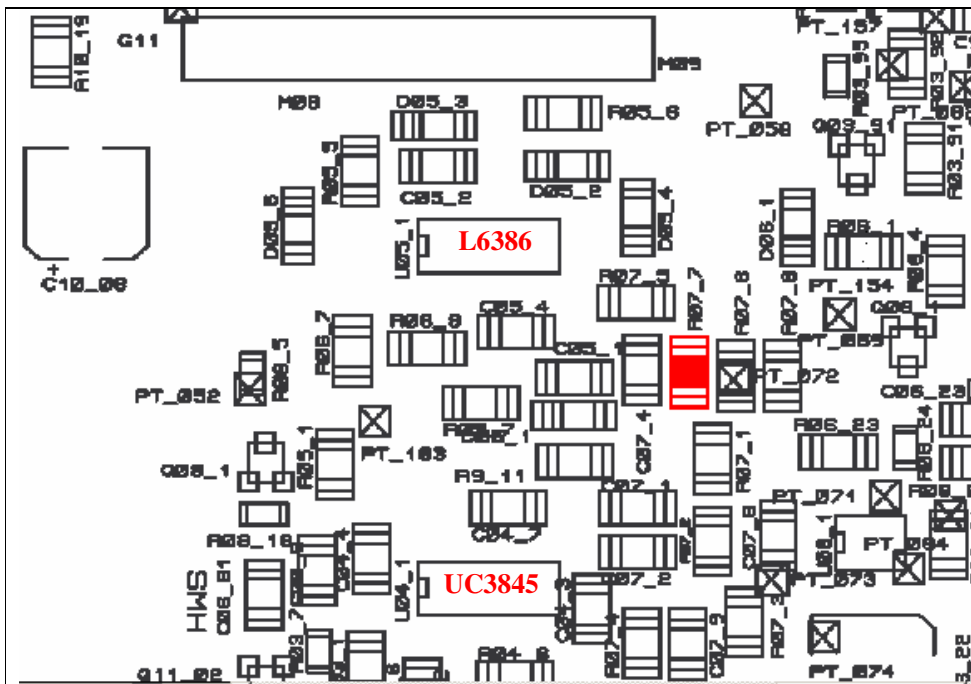
PCB INDEX IMPACTED BY THIS MODIFICATION : PCBs manufactured before [May 2006](#).

In the PWM generator area, R07_7 is located close to the UC3845 and L6386 components.

Remove this 220 Ohm resistor in order to limit the short circuit current on the product.

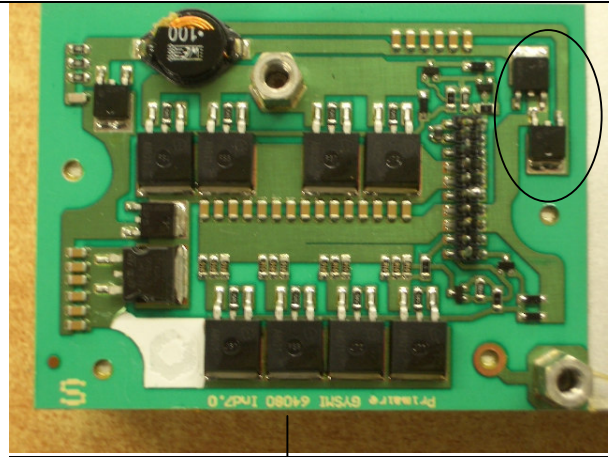
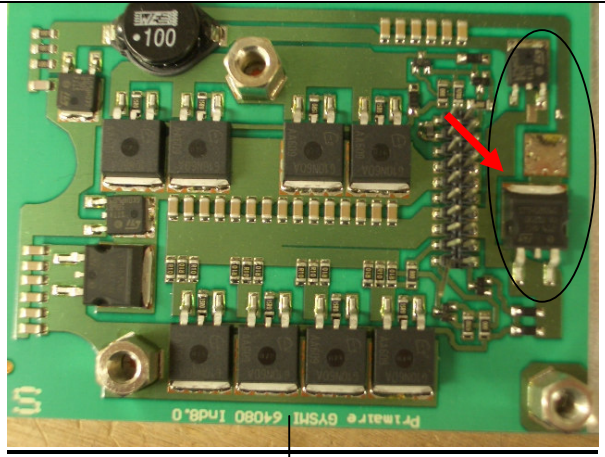
*PCB INDEX IMPACTED BY THIS MODIFICATION : PCBs manufactured before **May 2006**..*

<p>When you have a gysmi 190 product with this version of IMS Module (little diode), you MUST change the power block.</p> <p>SMI version < ind.8</p> <p>If the power block is burnt and is from this version refer to technical assistance ANNEX 1 in order to have the list of the components to change on the main PCB.</p>	<p>This version is the new version, the only difference is the demagnetisation diode with a bigger box.</p> <p>SMI version ind.8</p> <p>This version of the SMI is assembled on our machines since May 2006.</p>

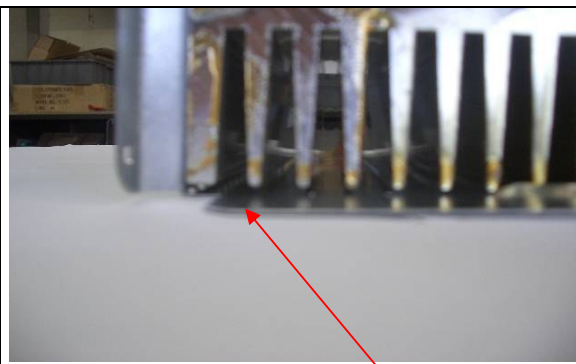
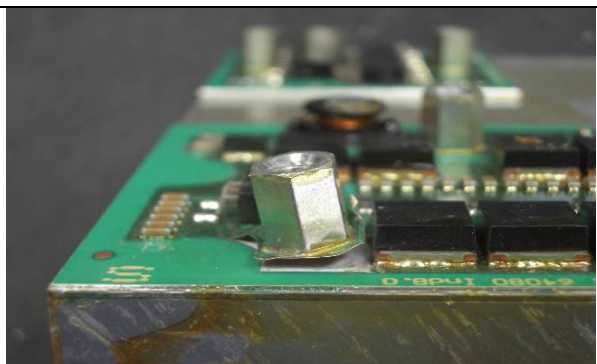
*PCBs IMPACTED BY THIS MODIFICATION: PCBs manufactured before **October 2006**.*

<p>1. There is a space between the heat-sink and the metallic plate.</p>	<p>2. Consequently, the mechanical strains breaks the tracks where the bolts are soldered.</p>

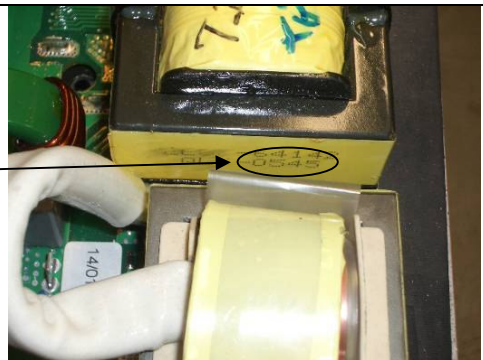
Products manufactured end of 2005 and beginning of 2006 are potentially impacted by this failure.

We have identified several batches of transformers which can be defective. Here are the references of the defective batches :

- 532
- 539
- 545
- 603

- apply 60V on the electronics board and measure the current consumption. If the current consumption is 0.04 A during the first 2 seconds, and then a peak of current is observed (well above 0.10 A), then the primary transformer is in short circuit.
- or measure the transformer inductance

This update is mandatory for transformers from this batch.

- *disassemble the power block in order to unweld the transformer*

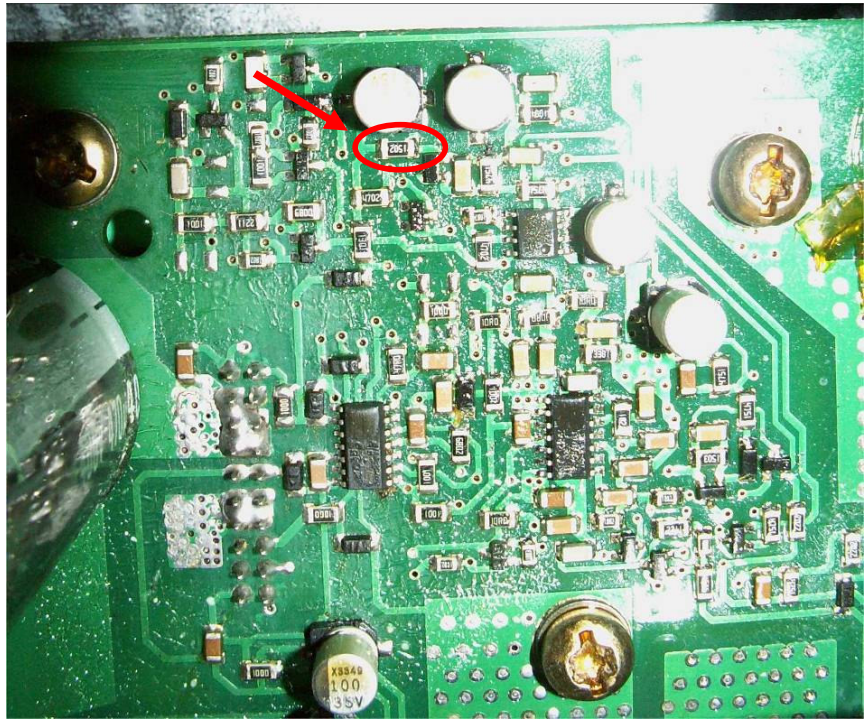
In order to improve the anti-sticking function on all the GYSMI 190 products, it is recommended to apply the following update. This update is applied in production since middle of May 2007.

In the PWM generator area, replace R06_3 (15K) by a 7.5 K resistor.
